# A Study on Future Perspective of Disaster-Prevention Studies Obtained through the Inspection of 2004 Indian Ocean Tsunami-Devastated Sites in Thailand

Tsunami, which was exemplified by 2004 Indian Ocean tsunami, notified the world of its threat, signifying quite a few unresolved issues on tsunami studies. In order to acquire on-site information and detect clues to the unresolved issues, Coastal Development Institute of Technology sent its own field survey teams to the tsunami-devastated sites of Thailand in March and April. This paper presented summaries of survey outcomes obtained in March field trip.

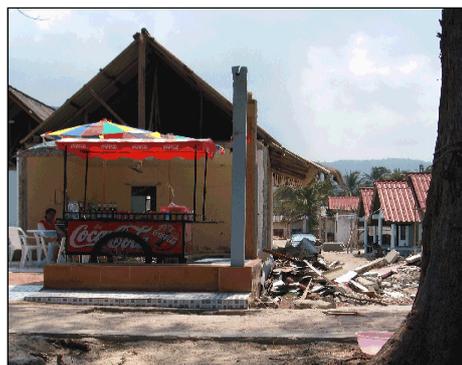
A resort house owner who experienced the tsunami said that he could escape from the first wave, because its height was below his body. The second wave 15 minutes later, however, was high enough to be over the roof of his house. While finding works for rehabilitation and rubble removal of some damaged facilities, we could also find many damages in other facilities. Impacts on facilities due to the tsunami can be characterized by collapses of their seaside walls, depicted in Fig.3, excepting their columns and base structures. These impacts are reduced according to the distance from the coast. Dwellings in further inland areas, however, also suffered from noted damages, which were supposedly induced by the invasion of the tsunami into intervals between resort houses. Most of pathways were significantly inflicted; especially some of their surfaces were depressed by the outflow of their sand bases. Such damages, depicted in Fig.4, were notable in their seashores with no plants.

Fig.3 A Resort House Damaged in its Front

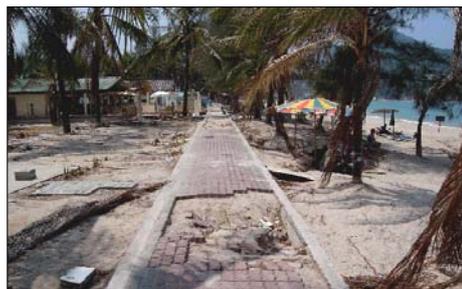
Fig.4 A Pathway Damaged by the Suction of its Base Sand

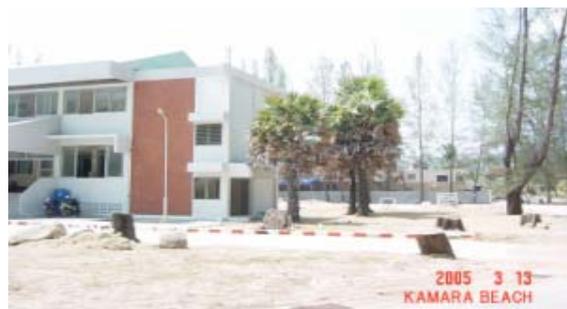
Hotels, fronts of which are open for the sea, also received severe damages, their recovery works going under way. It is considered that, judging from the discoloration of its nearby Palm trees' leaves, the police station, located near the coast road in the north of hotels, was struck by 4 to 5-meter high tsunami, remaining intact due to its firm structure depicted in Fig.5. In contrast, disastrous damages of wooden houses in further inland area, depicted in Fig.6, are characterized by missing walls in their first floors, and corruptions of their foundations. It is presumed that these damages were caused by the passage of highly energized tsunami.

Fig.5 Unaffected Building of Police Station

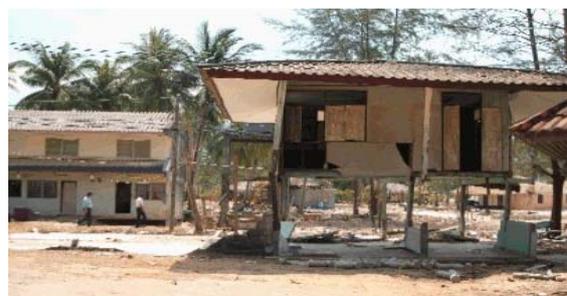
Fig.6 A Wooden House Sustaining Columns in its First Floor

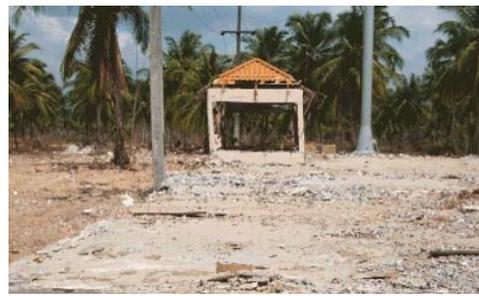
Attentions should be paid to Fig.8 showing a damaged house, around which its back and forth walls facing the sea were missed and rubbles of its 10-centimeter thick walls were scattered around. In addition, several bicycles also lay broken inland.

It is presumed that all aforementioned damages were also caused by same phenomenon as that in Kamala beach.

Fig.8 A House Damaged in its Seaside Wall

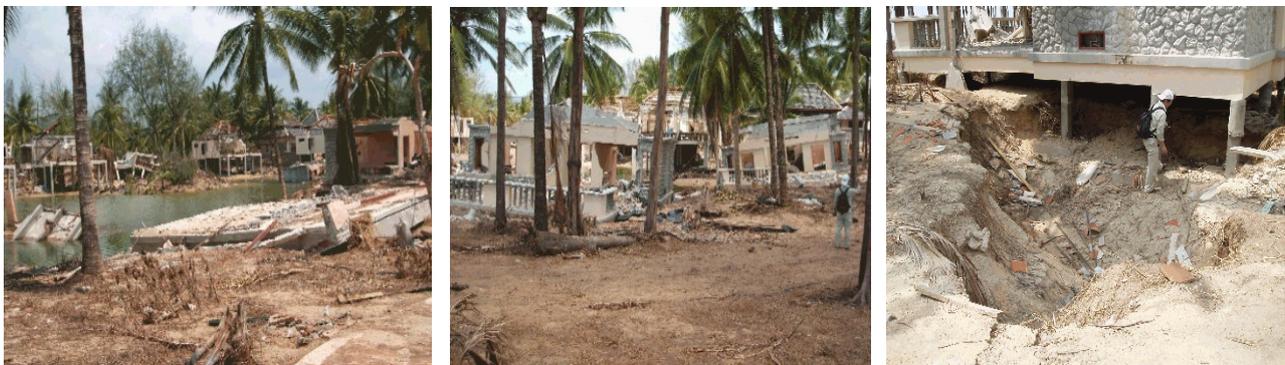
We made surveys on damages around Theptharo Lagoon Beach Resort in Khuk Khak beach of Central Kao Lak. There were dotted cottages, each of which are 10 meters wide, 15 meters deep and 4 meters high, along the coastline of lagoon shaped as sandpit. Since simple structures were installed in cottages, all of them suffered from such severe damages as disconnections between their superstructures and substructures, fractures of their members, inclinations or collapses, submersions under the lagoon and so on. We found disappearances of their front walls or collapses of their column in half of cottages. As for cottages near the sea, their damages, which are noted as complete collapses of their structures or those of their superstructures such as columns and walls, were more significant than cottages along the lagoon. Two cottages located farthest from the coast, however, remained comparatively intact, receiving small injuries only in their walls. Besides, traits of corrosion were also found in footings of many cottages. Most of pile foundations that were installed in the lagoon remained structurally sound. Many of newels on balconies, though they are set in forefronts of cottages, remained undamaged.

Fig.7 Damaged Cottages

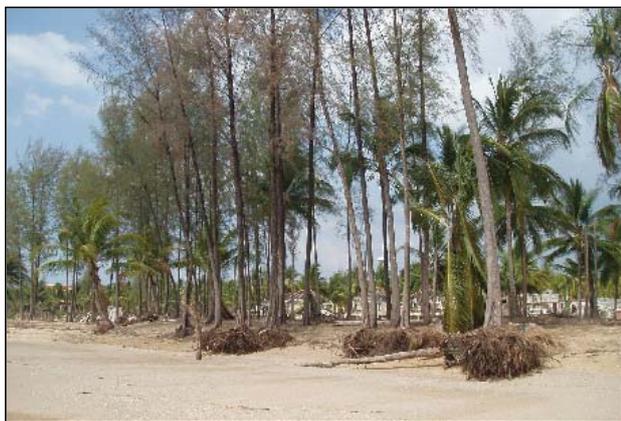
It indicates that planting strip with its observed degree of planting density did not perform enough to weaken the strength of the tsunami. Furthermore phenomena that roots of the trees prevented the outflow of beach sand and the collapse of ground were found not only in some spots but also in other beaches

Fig.10 Corrosions at Bases of Trees
